PREVENTION OF
REPEATED
DROPPED OBJECTS
BY
IMPLEMENTING
OEM'S RECOMMENDATION

DROPS WELLS FORUM 2024.10.29

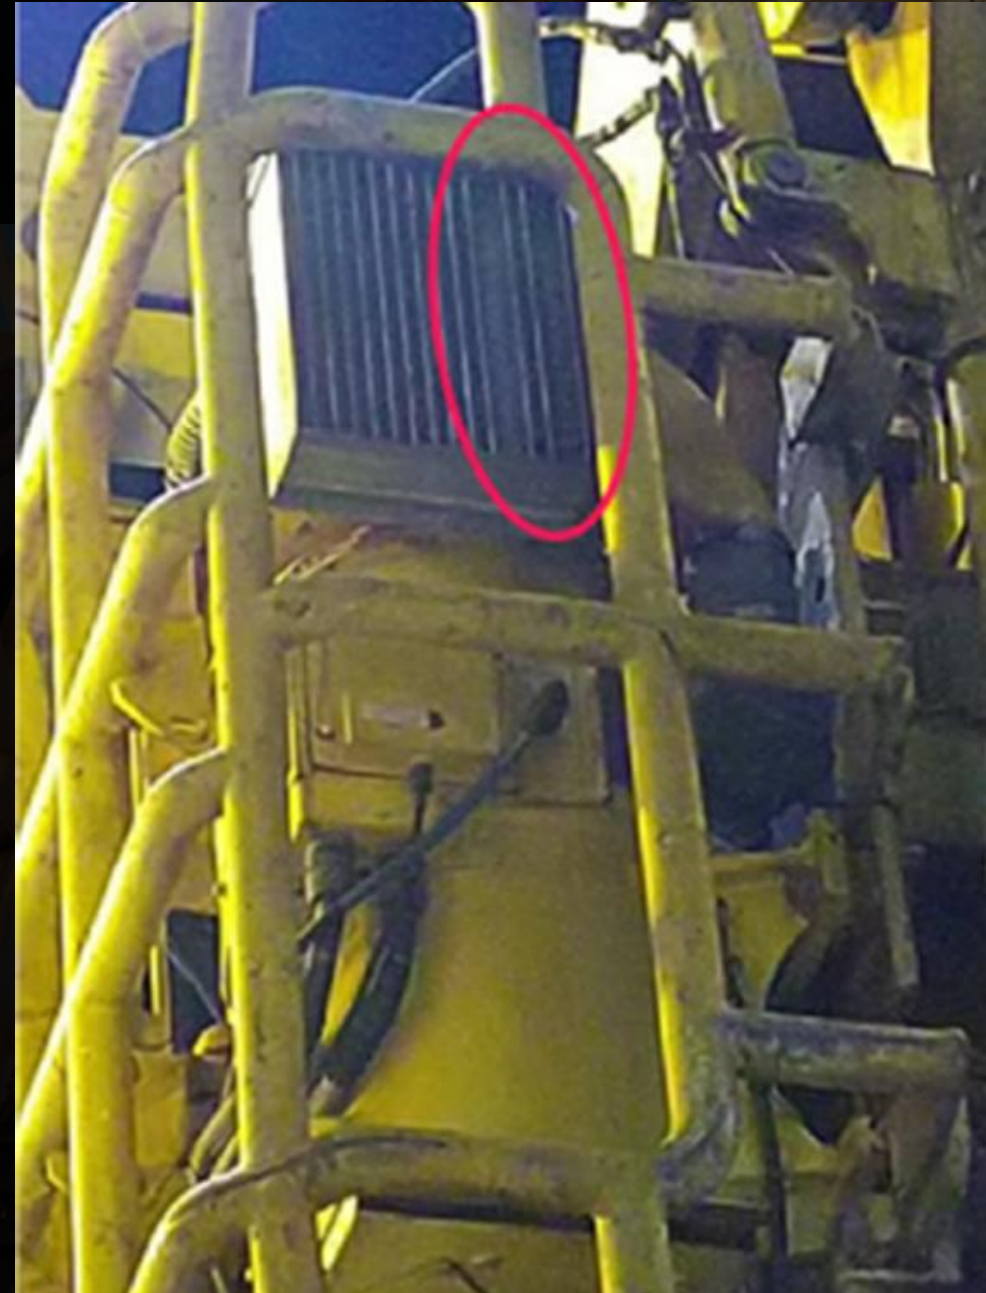
Top Drive cooling blower guard fin drops 26 meters to rig floor (while performing Drawworks calibration). A piece of aluminum (58cm x 8.5cm) weighting 350 grams was observed on the rig floor 3 meters away from rotary table well center.

Video footage and SDI recovered showed that the aluminum fin had fallen from a height of 26 meters.

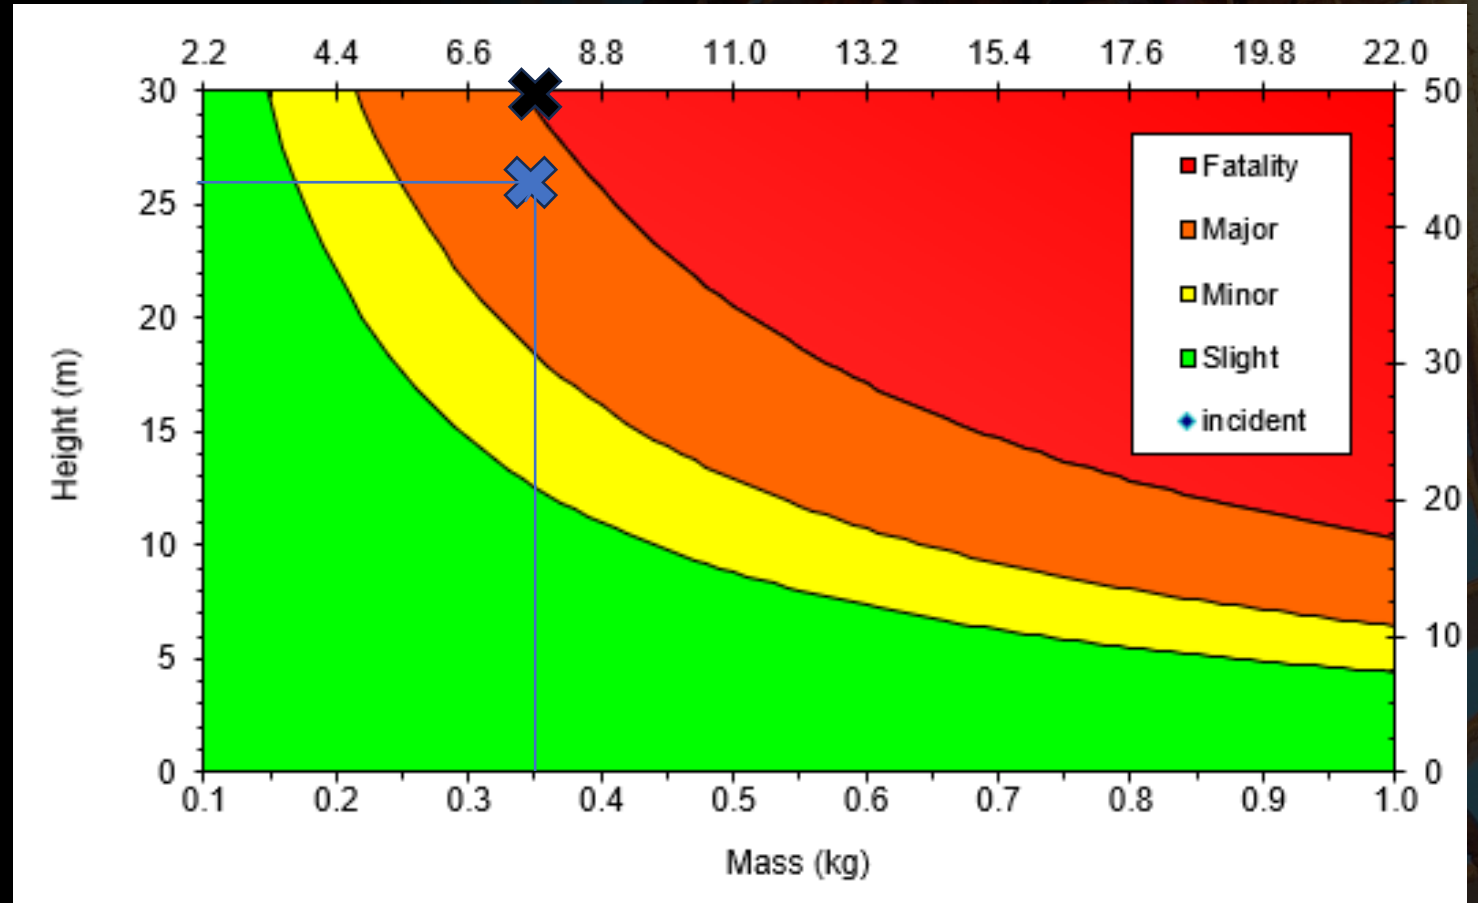
weight **350g**
aluminum fin
had fallen from a
height of **26m**

Energy ca 90J

MAJOR: A Lost Time Incident (LTI).
Non-fatal traumatic injury that
causes any loss of time from work
beyond the day or shift it occurred.
Also referred to as Day Away From
Work Case (DAFWC).

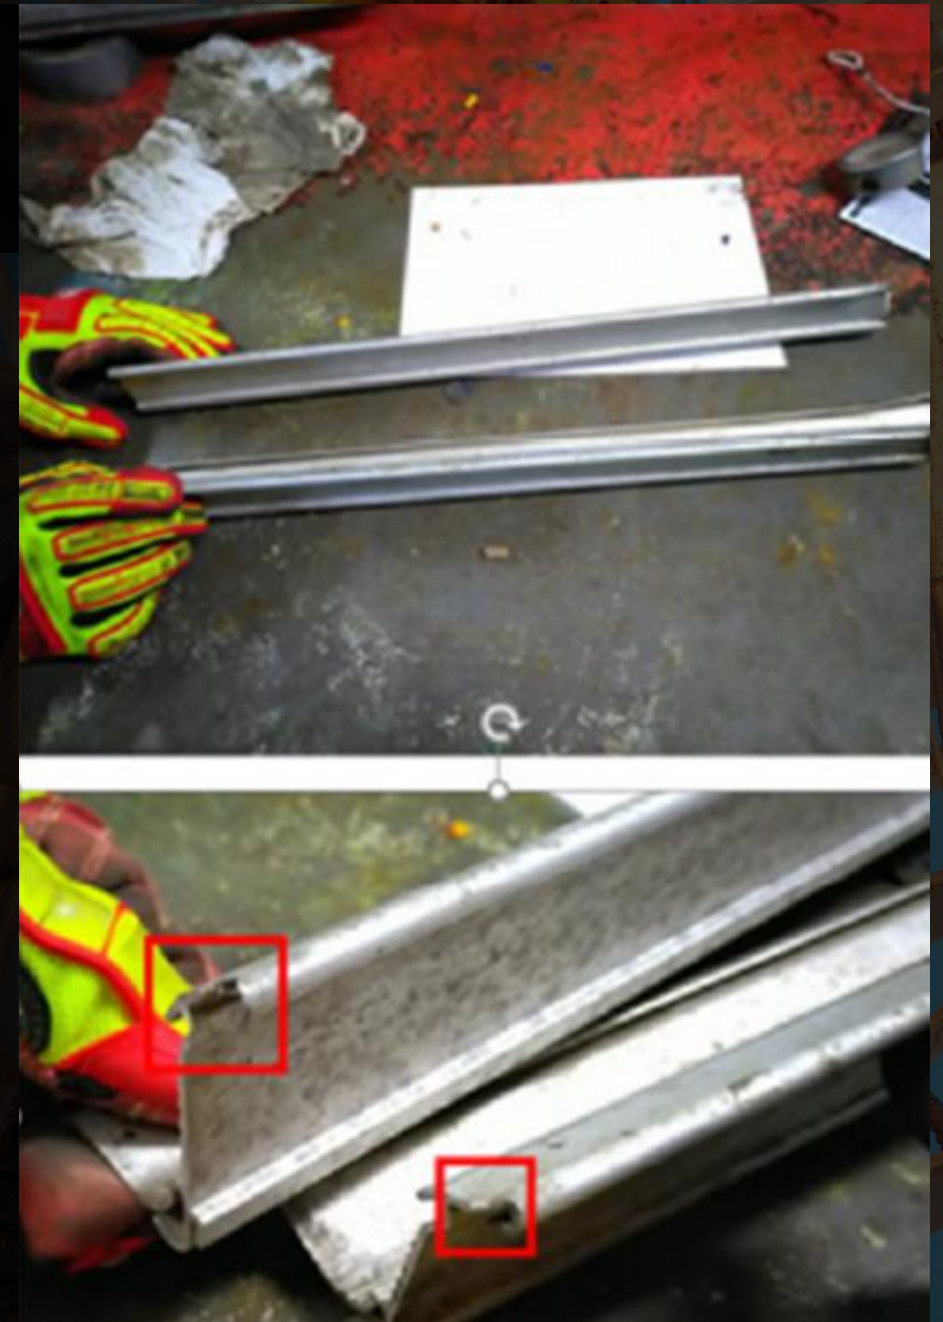
Weld type/quality combined with heavy drilling is the original root cause identified (April 2023).

The Customer not implementing product bulletin recommendation allowed a similar incident to occur.
